Rapid Drawdown with Multi-Stage

1 Introduction

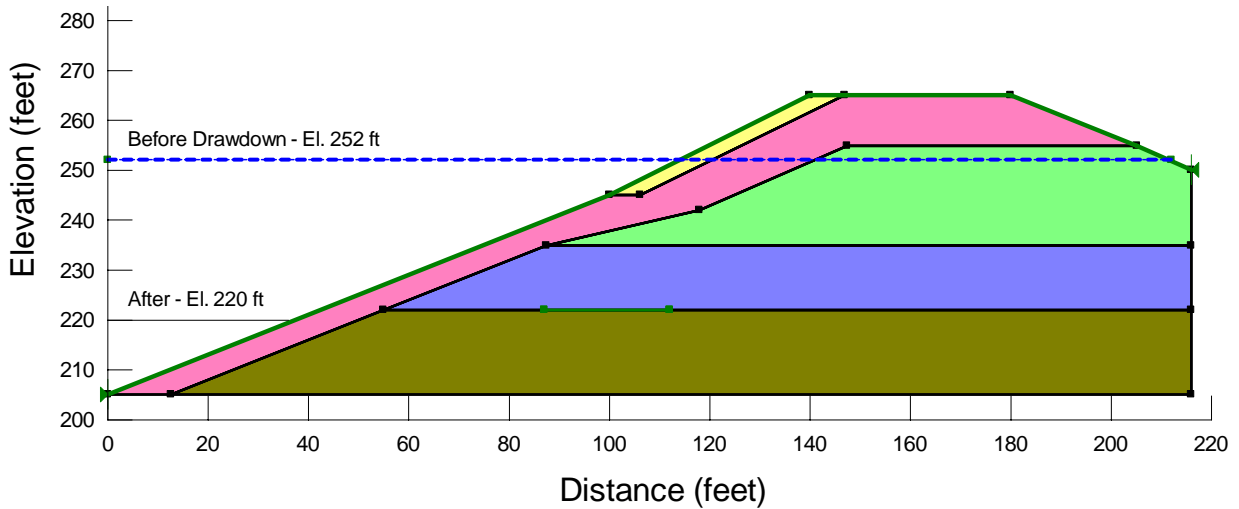
The Walter Bouldin dam failed on February 10, 1975 during an extremely rapid drawdown of 32 feet in 5.5 hours that occurred as a result of a piping failure in another section of the dam. The dam is a rolled earthfill embankment. As shown in Figure 1, the dam is approximately 60 feet high. The lower portion of the dam is clayey sandy gravel that was not involved in the slide. Overlaying the gravel are a layer of clay, a zone of silt and a clayey silty sand layer that blankets the slope. The upper portion of the upstream slope is blanketed with riprap. The upstream slope is 2 on 1 above Elevation 245 and 2.5 on 1 below.

Figure 1 The Geometry of the Walter Bouldin Dam

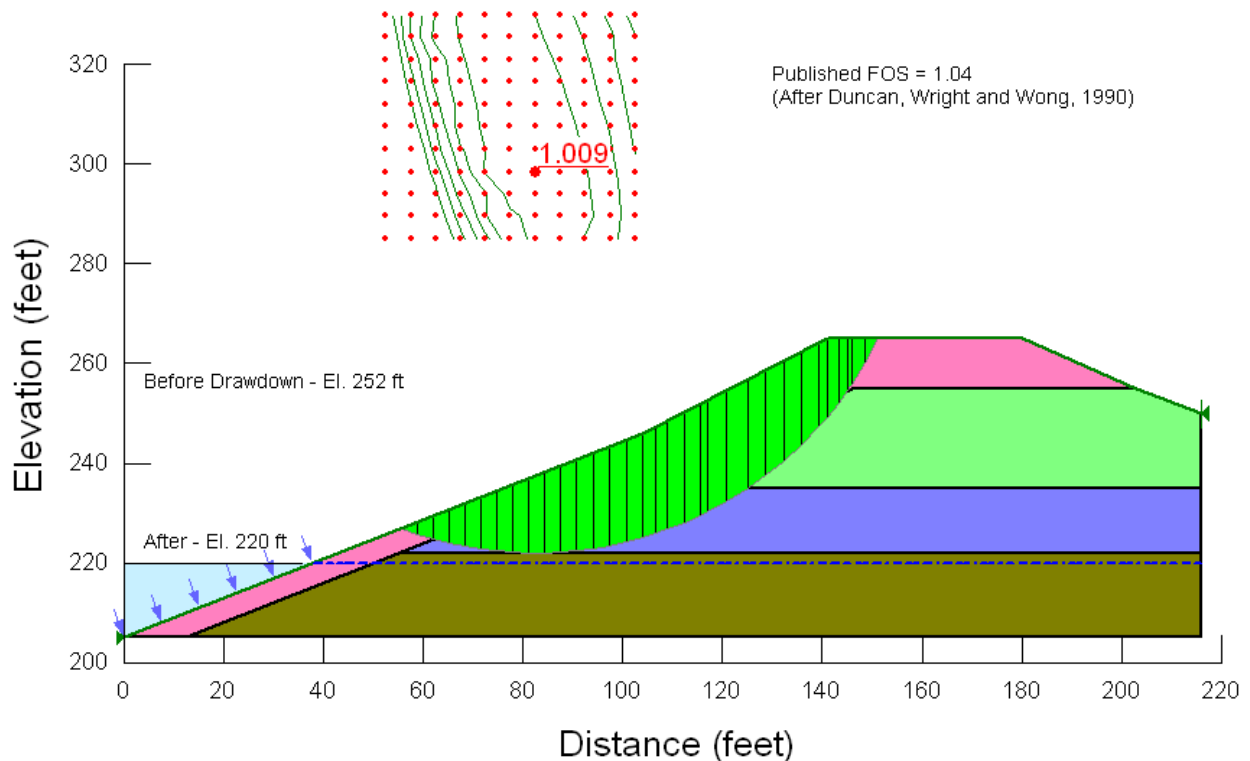
Figure 2 shows the slip surface and the SLOPE/W computed factor of safety using the 3-stage undrained strength method. The factor of safety is 1.009, which is essentially the same as the factor of safety obtained by Duncan, Wright and Wong (1990).

Figure 2 SLOPE/W Computed Factor of Safety Using the 3-Stage Undrained Strength Method

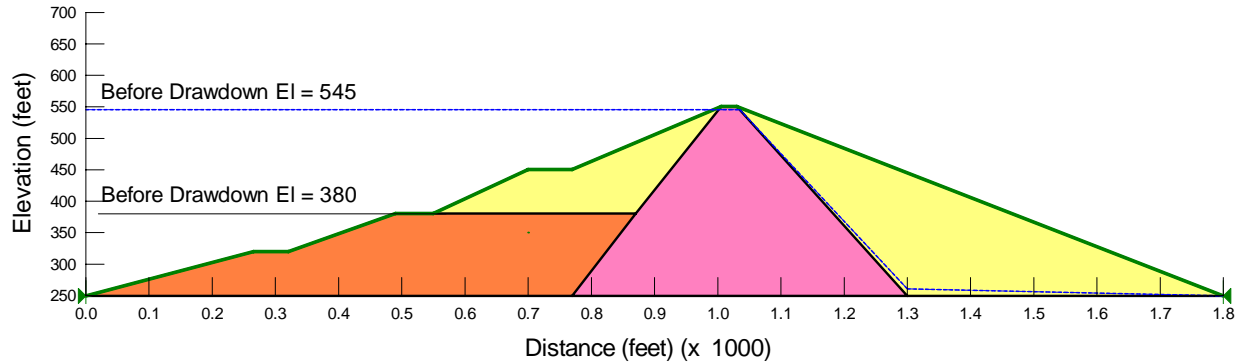
The geometry of the Pumped Storage Project Dam is shown in Figure 3. The dam is about 300 feet high. The embankment has a densely compacted silty clay core. The lower portion of the upstream slope is a random zone with the same strength properties as the core. The upper portion of the upstream slope and the downstream slope is free draining rockfill.

The before drawdown water level is at 545, and the after drawdown water level is at 380, which is the elevation of the bench at the mid-height of the embankment. The drawdown results in complete dewatering of the upstream rockfill shell and a portion of the filter layer beneath the shell.

Figure 3 The Geometry of the Pumped Storage Project Dam

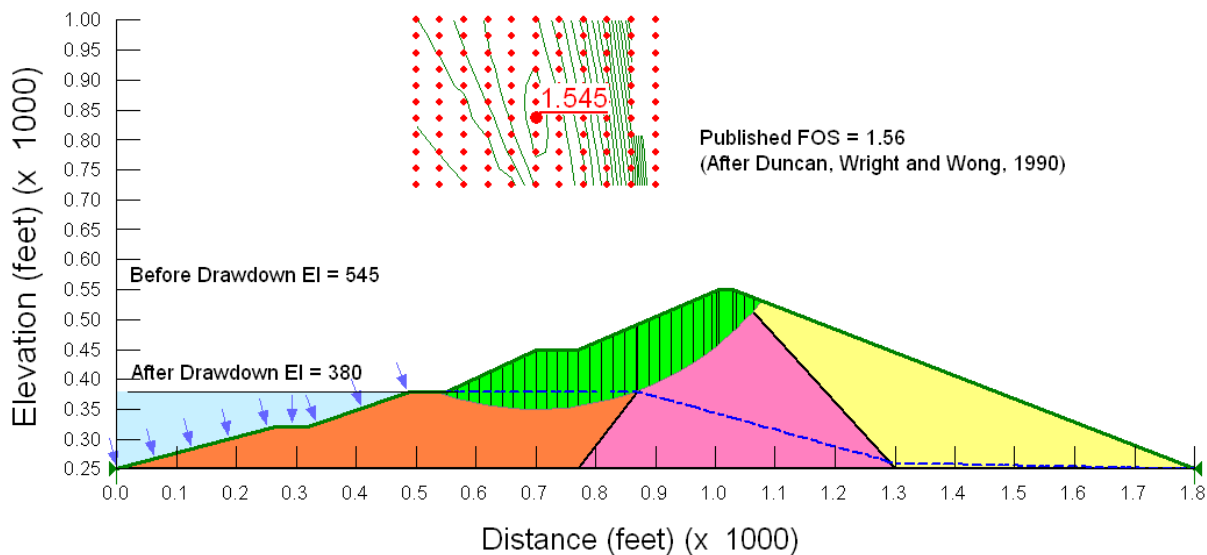
Figure 4 shows the slip surface and the SLOPE/W computed factor of safety using the 3-stage undrained strength method. The factor of safety is 1.545, which is almost identical to the factor of safety obtained by Duncan, Wright and Wong (1990).

Figure 4 SLOPE/W Computed Factor of Safety Using the 3 Stage Undrained Strength Method

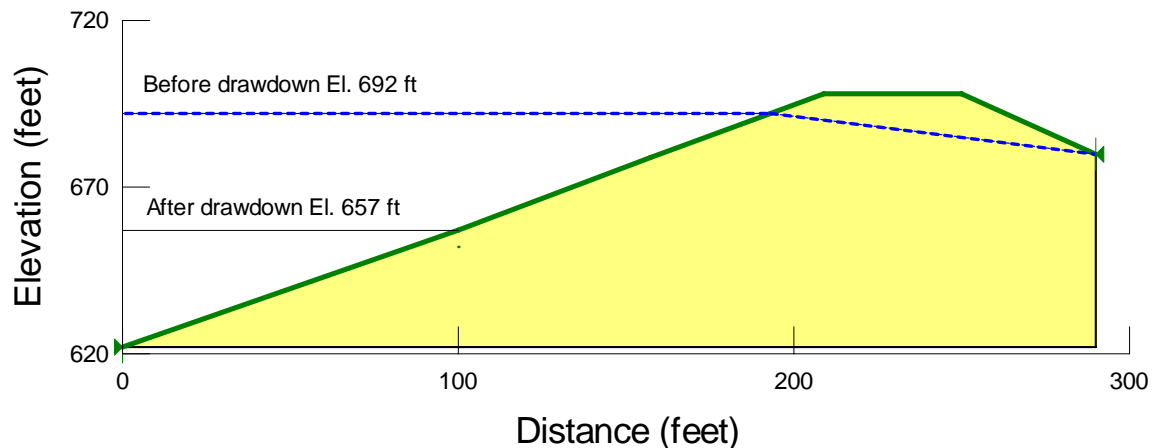
The Pilarcitos Dam is a homogeneous rolled earthfill embankment. The crest of the dam is about 78 feet above the upstream toe, as shown in Figure 5. The embankment failed when the water level was lowered from elevation 692 to 657 between Oct 7 and November 19, 1969.

The material comprising the embankment is classified as a sandy clay (CL) with 60 to 70 percent passing the number 200 sieve and a saturated hydraulic conductivity of about 4×10^{-6} m/s. The liquid limit is 45 percent and the plastic limit is 23 percent. The effective and total strength parameters used in the analysis are:

Figure 5 The Geometry of the Pilarcitos Dam

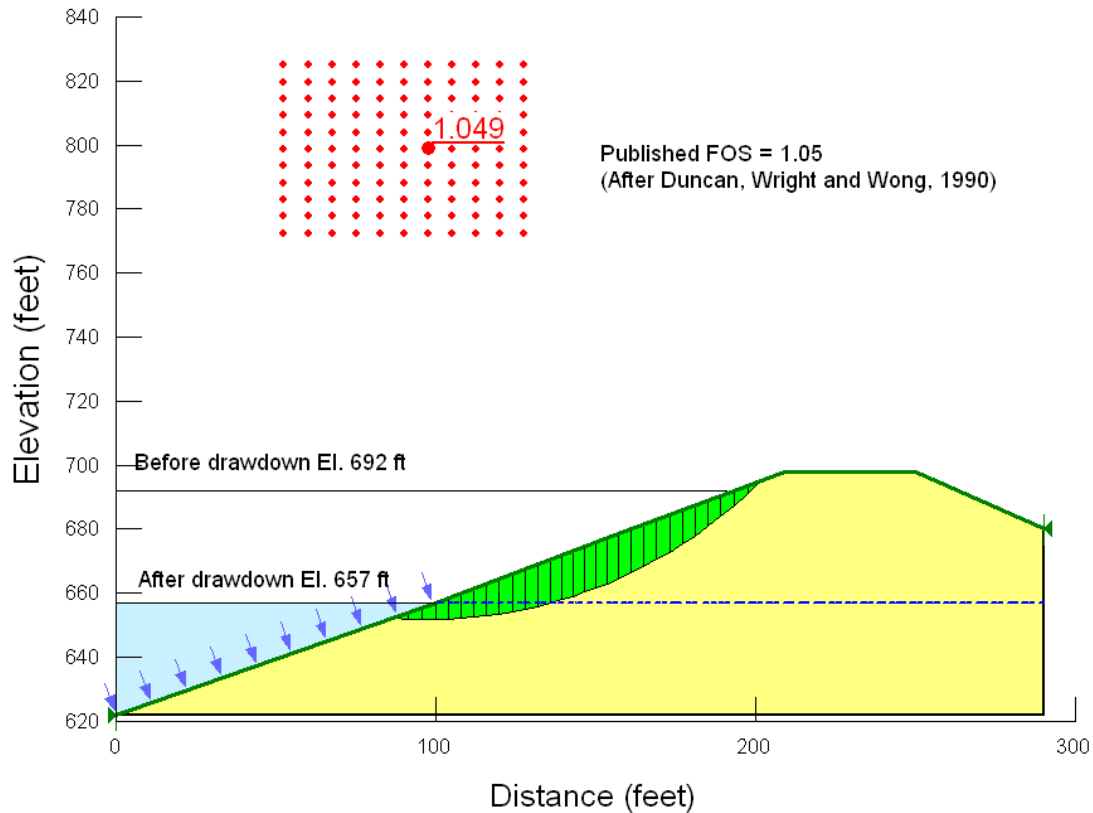
Figure 6 shows the slip surface and the SLOPE/W computed factor of safety using the 3-stage undrained strength method. The factor of safety is 1.049, which is essentially the same as the factor of safety obtained by Duncan, Wright and Wong (1990).

Figure 6 SLOPE/W Computed Factor of Safety Using the 3 Stage Undrained Strength Method

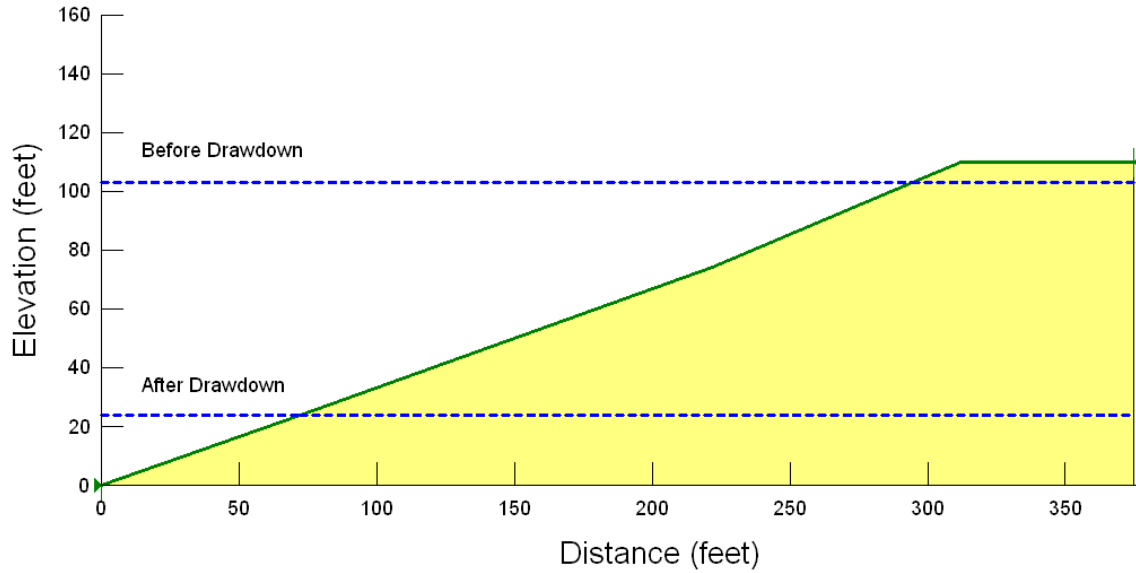
Example 4 is the benchmark example used by the U.S. Army Corps of Engineers (2003) in the Appendix G of the Engineering Manual – EM 1110-2-1902. It is a simple homogenous embankment. The material properties are:

The slip surface is established by a center located at $x=169.5$ feet, $y=210$ feet and a radius of 210 feet. Drawdown is from a maximum water level of 103 feet to a minimum level of 24 feet. The upstream slope is 3 to 1 up to elevation 74 and 2.5 to 1 above elevation 74.

Figure 7 The Geometry of the USACE Bench Mark Example

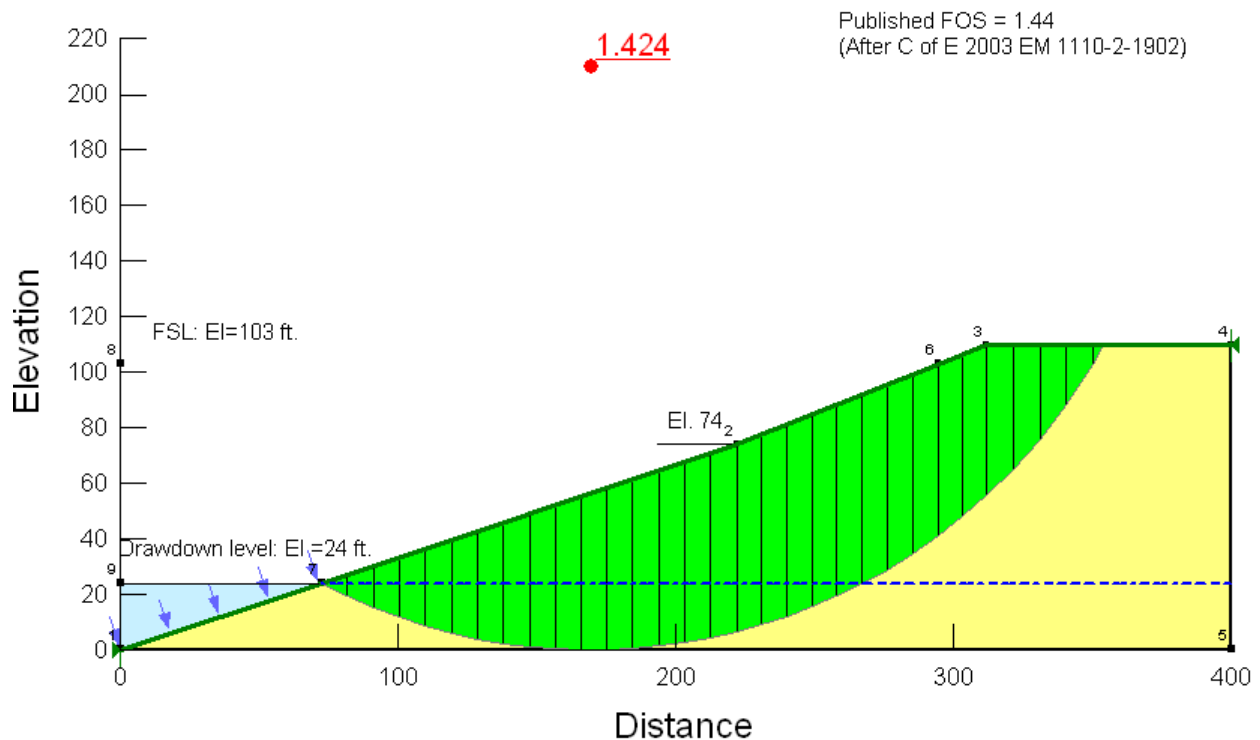
Figure 8 shows the slip surface and the SLOPE/W computed factor of safety using the 3-stage undrained strength method. The factor of safety is 1.424, which is almost identical to the factor of safety as presented in the Corps of Engineers (2003) engineering manual.

Figure 8 SLOPE/W Computed Factor of Safety Using the 3 Stage Undrained Strength Method
